Coca-Cola Zero dublinbikes Mini-Expansion - Assessment of Additional Station Potential

Site 1 Evaluation

The Irish Volunteer Monument, Blackquiere Bridge, North Circular Road.

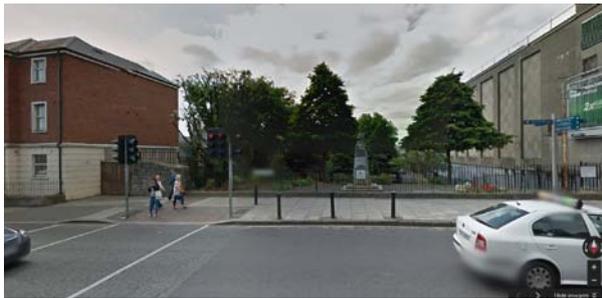
Demand would be such that this area would need to be served by a 40 stand station. Given the limited space available to accommodate a station to the footpath, the only option would be to encroach on the park which would be undesirable and impractical from several perspectives. Traffic congestion, particularly at peak times in the vicinity of this location would preclude safe servicing of the station. A designated service area, which is not currently legislated for, would be required and again space constraints would prohibit the provision of such an area in any event. The existing layby, even if it could be designated for scheme service vehicles only, is too remote from the station and its use could lead to conflict between pedestrians and staff wheeling bikes along the narrow path back and forth to the station. The inefficiency of servicing a station under these conditions could have a detrimental knock on effect on service levels across the network.

Heavily subscribed layby in vicinity of 18 metres.

Layby remote from station and could not be used if other vehicle parked, therefore unlikely to work operationally.

No secondary regulation possible on DYL in location given roadway characteristics.

Negative impact on setting/interpretation of monument/park (on anniversary of 1916).

If within park, will require complete removal of monument and railings.

Network location will require a well regulated station of 40 stands at c32m in length.

18 metres available but would leave insufficient minimum footpath width.

Location on footpath would impact on natural desire line/pedestrian crossing.

Possible issue for visually/mobility impaired.

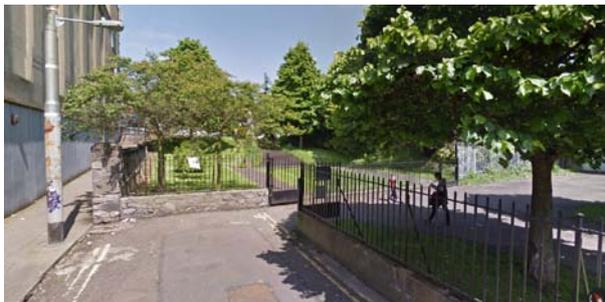
Broadstone Park, Royal Canal Bank

This location does not conform to the general principles of site selection that have been applied successfully across the existing network. The location is distant from public areas. There is very limited scope for passive surveillance of the station and this could prove to be a prime site for vandalism to develop. There is poor access and egress for service vehicles. The service vehicle would have to reverse for some distance in an area that would be frequented by pedestrians and cyclists if a station were installed. This would be both unsafe and impractical. Access to this area is likely to prove difficult during peak traffic congestion periods, a fact exacerbated by the fact that legislation prohibits use of bus lanes. Consequently bikes are likely to be abandoned at the station leading to increased subscriber dissatisfaction and possible theft of bikes.

Restricted access to park via narrow residential 'street' with on-street car parking. Insufficient width to provide safe vehicular access for regulation.

Adjoining access lane to park not in charge.

Negative impact on park interpretation/setting.

Poor general surveillance.
Some anti-social activity observed.

Will require significant vehicle manoeuvring and reversing movements to regulate.

Serious safety concern with respect to vehicle and pedestrian/cycle interaction.

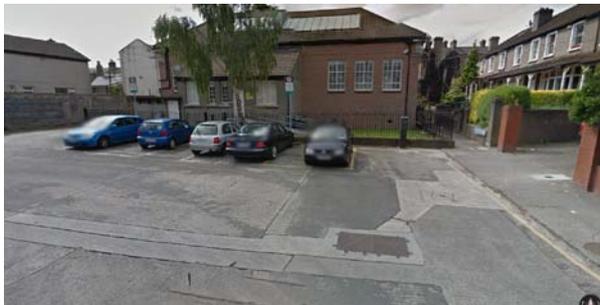
Rear of Phibsborough Library at Royal Canal Bank

This site suffers from many similar problems to Site 2, and while vehicular access may be slightly better, service access would still involve a convoluted route beyond the current network that would not be operationally efficient. The long tail swing of the service vehicles would make the negotiation of the turn at North Circular Road to the left of the library difficult to accomplish safely, especially with pedestrians in the vicinity.

The lack of the ability to have an exclusive demarcated servicing area marked on the road for the service vehicle at such a distant network location introduces increased risk that a long service journey would have to be aborted on arrival, as even one vehicle incorrectly parked at this location would prevent the vehicle stopping without hindering other traffic. This could lead to likely conflict with residents or those using the library. Such inefficiency would damage service levels across the network.

Problematic access with difficult turning movement from North Circular Road and complication of one-way system.

Will require removal of on-street car parking spaces, inc. mobility impaired in area heavily subscribed for residential car parking as well as visitor short stay.

Poor general surveillance.
